RESEARCH MEMORANDUM

PRELIMINARY INVESTIGATION OF SEVERAL ROOT DESIGNS FOR
CERMET TURBINE BLADES IN TURBOJET ENGINE

III - CURVED-ROOT DESIGN

NATIONAL ADVISORY COMMITTEE
FOR AERONAUTICS

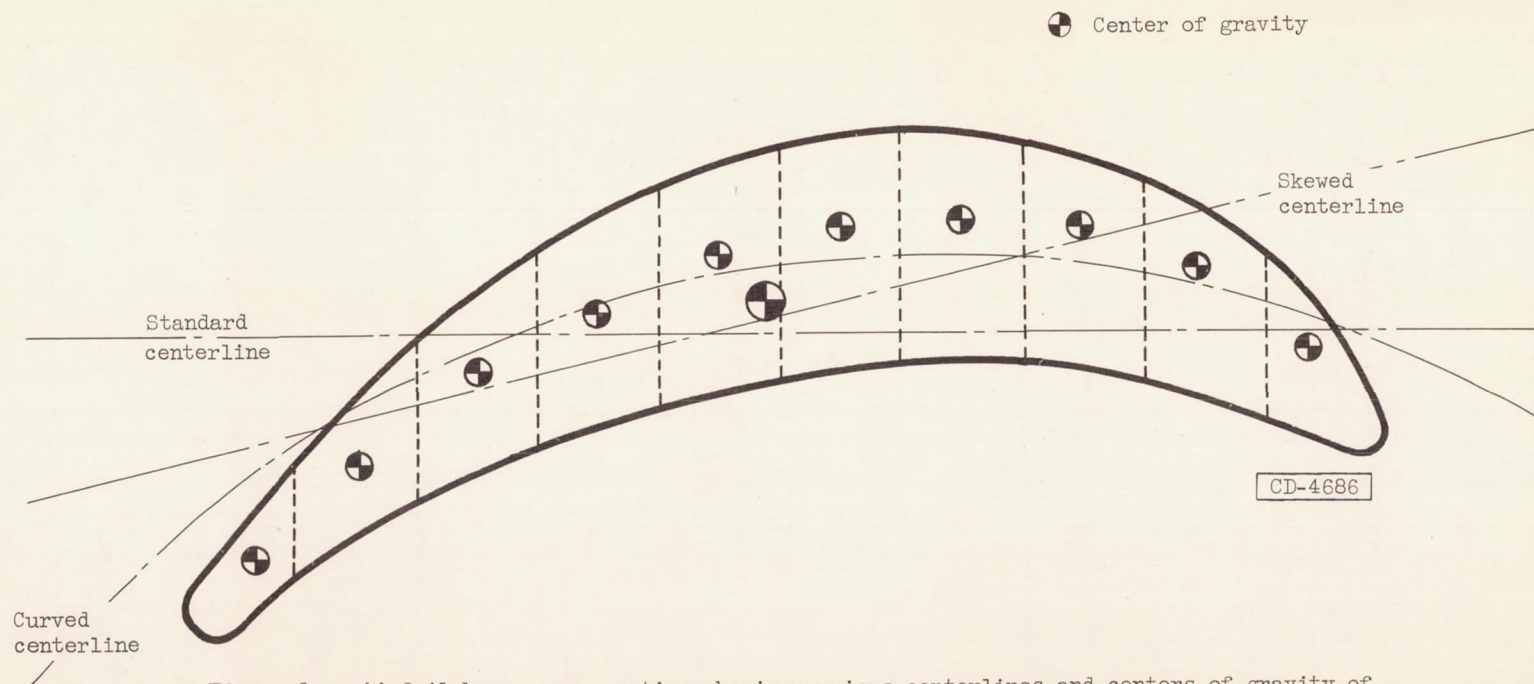
To determine the optimum root centerline for the curved root blade, the airfoil was divided into ten radial columns instead of in halves. The computed center of gravity of each column was plotted on the base cross section of the airfoil (fig. 1).

Figure 1. - Airfoil-base cross section showing various centerlines and centers of gravity of whole airfoil and of ten radial columns.

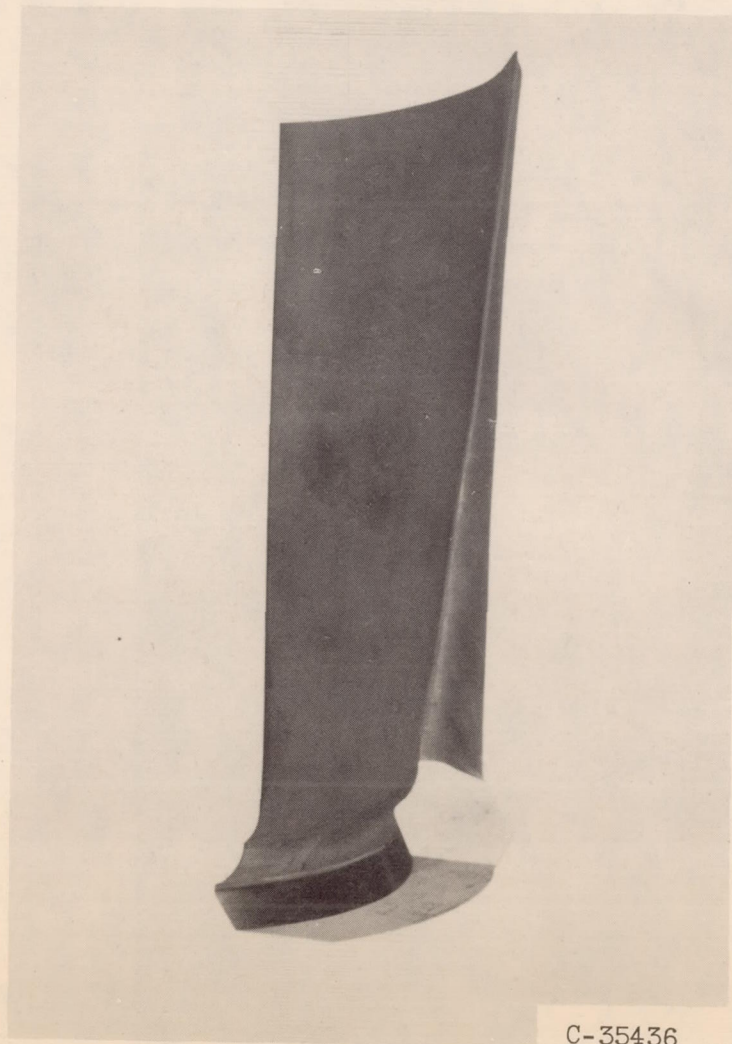
C-35436

Cermet blades with a curved root (fig. 2) were fabricated by Kennametal Inc. The airfoil was the same shape and size as those of the standard metal blades, as were the cermet blades discussed in reference

Figure 2. - Curved-root cermet turbine blade.
